McFarland-Sanger House
148 Lumber Street
Hopkinton, MA

Jenn Doherty
Boston University
Spring, 2011

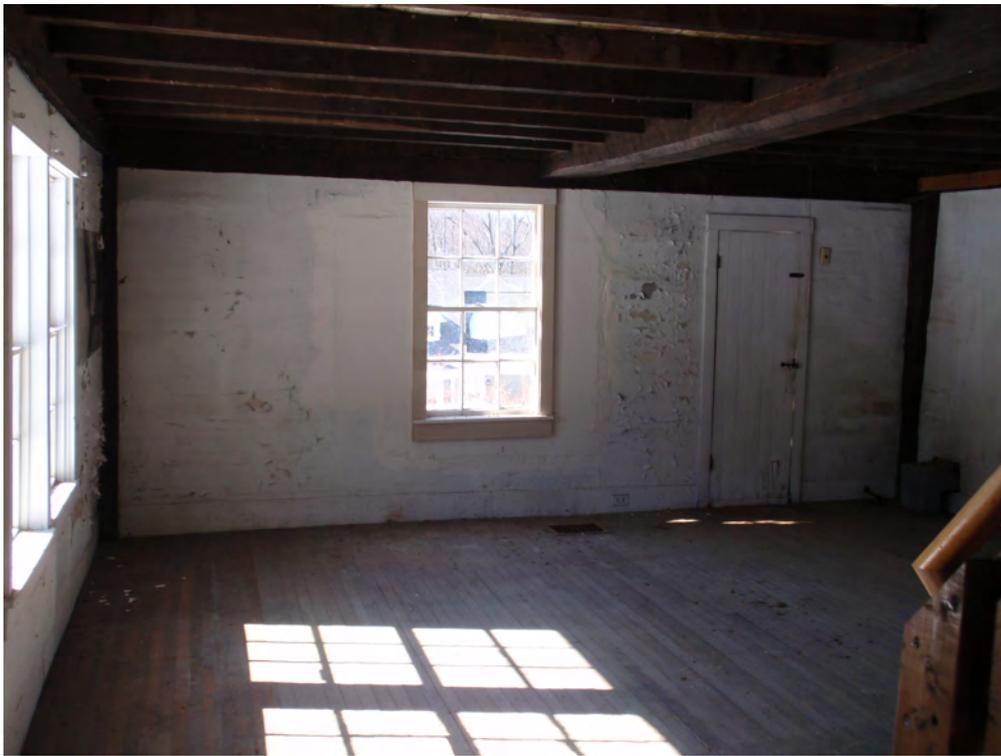
The first phase of major construction was the west hall (*fig. 2*). This early house was a single room with a chimney bay, constructed out of oak using traditional timber framing methods. Presumably six posts supported the frame originally, although the two northeastern ones have been removed and only four remain. The posts are not square but rather gunstock, to support all the joinery of the framing members. Unusually large diagonal braces gave the frame even more support. One of these braces is visible in the southwestern corner, and photographs from the town's renovations show another cut off in the northwestern corner (*fig. 3*). Peg holes are visible over a number of the windows, suggesting the placement of the other braces and that the windows are probably not in their original locations. The chimney bay is notable for its unusual depth, almost nine feet. This would have been a lot of space given over to a single chimney stack.

Fig. 2 – The west hall

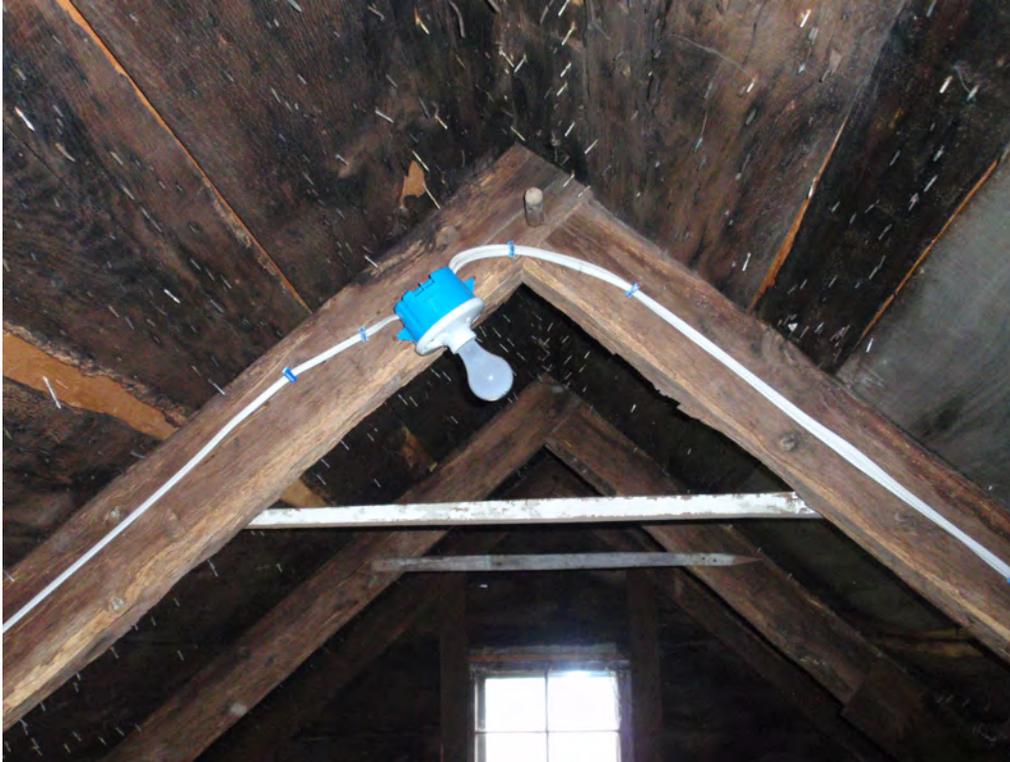
In the attic of this original house, the six original rafter sets are visible, creating a common rafter roof with no purlins. The rafters are joined at the ridge and pegged together, instead of meeting at a ridge beam (*fig. 4*). These rafters have visible numbering on them, from when they were laid out and joined prior to raising (*fig. 5*). Starting at the east end of the west hall, numbers one through five are visible, with six presumably being on the outside of the end rafter at the west end of the house. A rafter now between numbers one and two is probably not

Fig. 4 – Rafters pegged together, no ridge beam

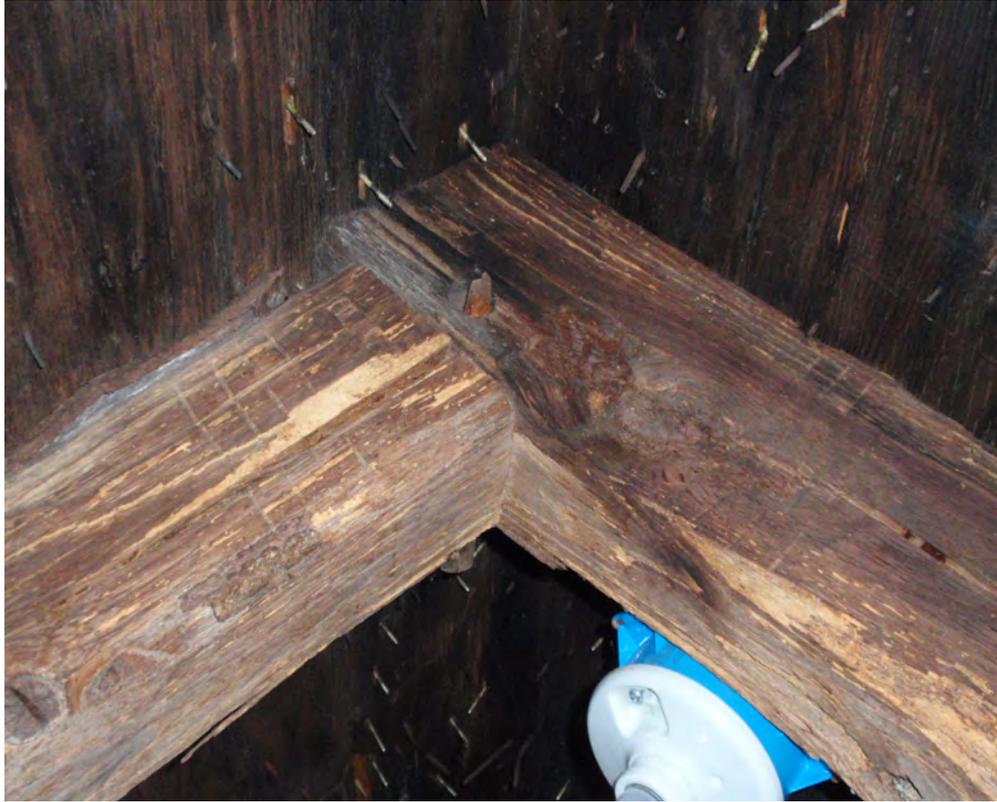
Fig. 5 – The number four rafters

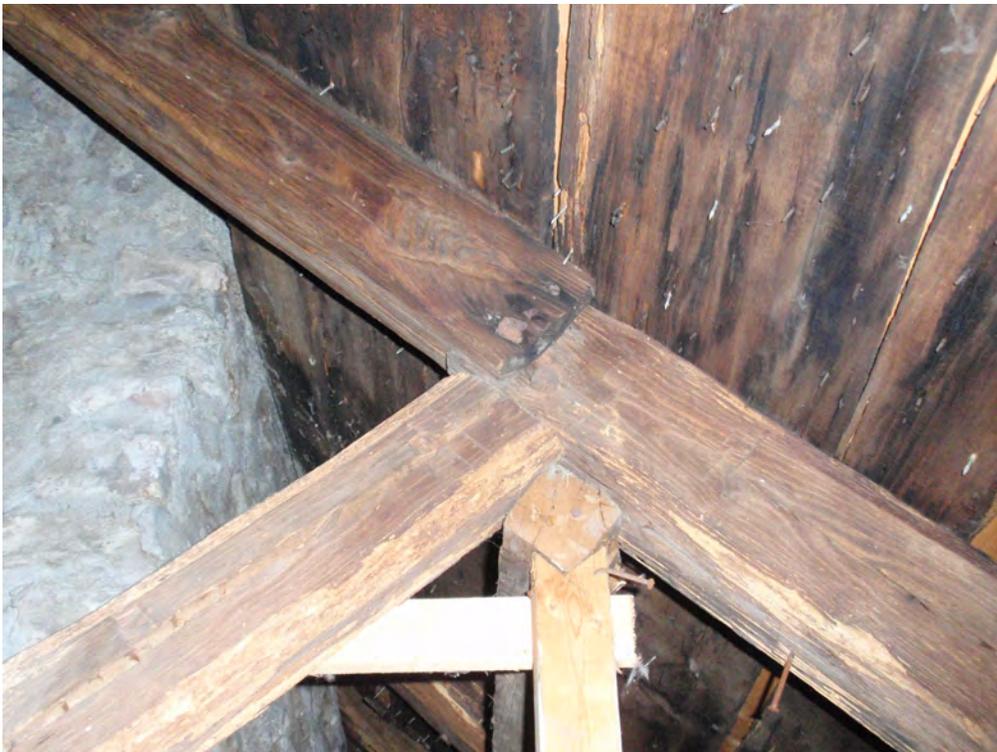
Fig. 6 – Work done to raise the north room roof

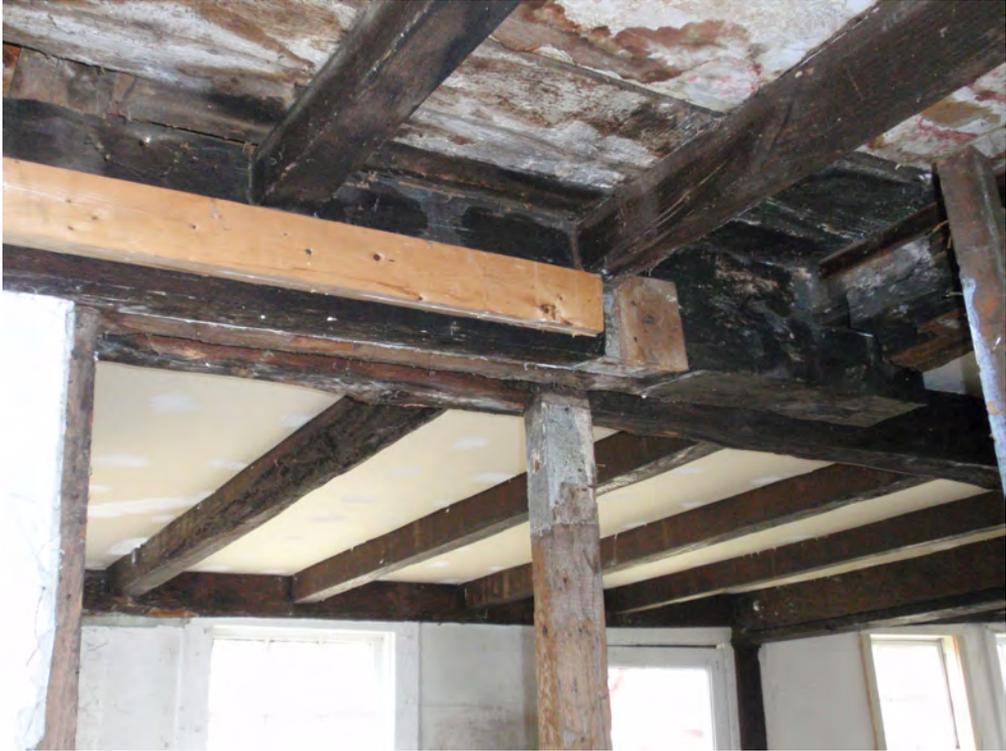
Fig. 7 – Missing posts and moved stud

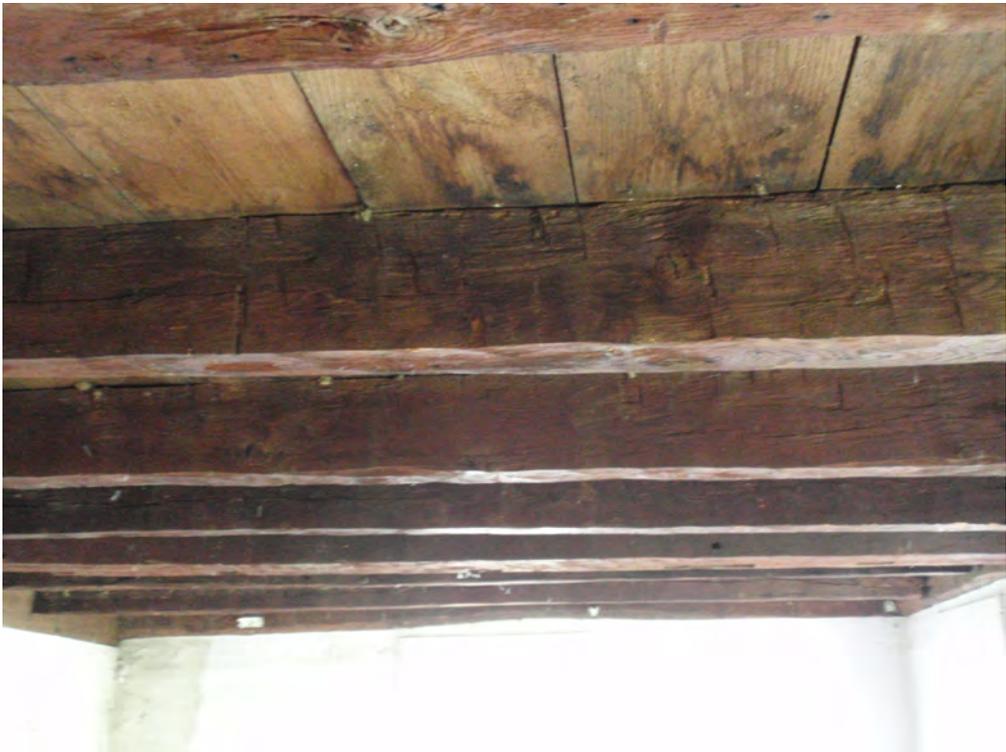
Fig. 8 – Joists of the east parlor

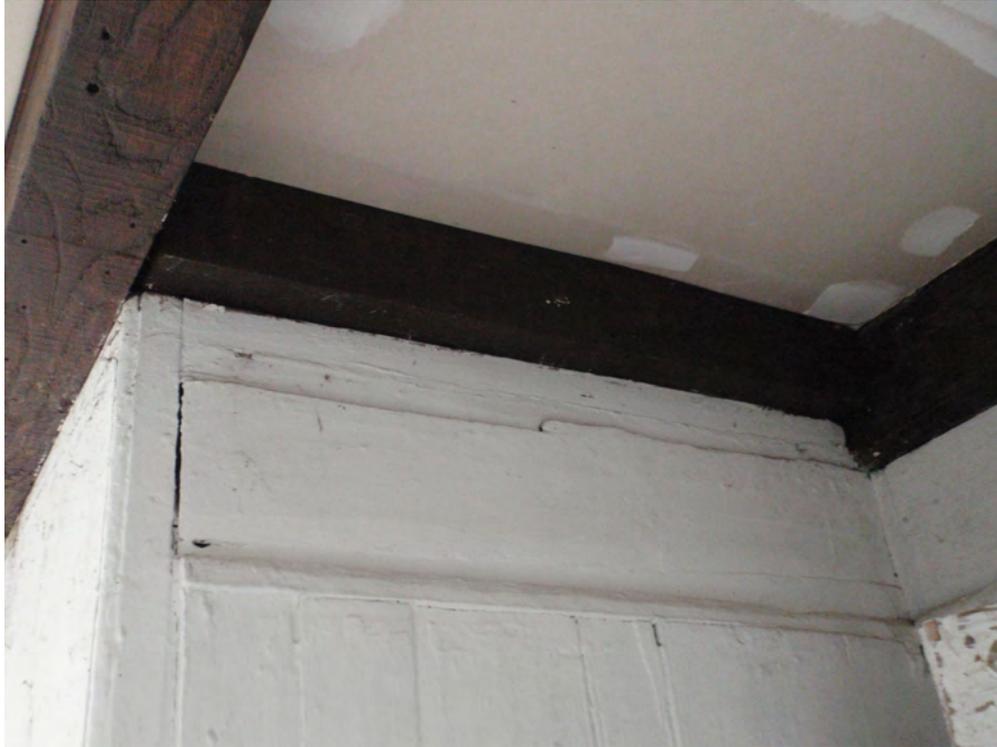
Fig. 9 – Stair trimmer mortised in

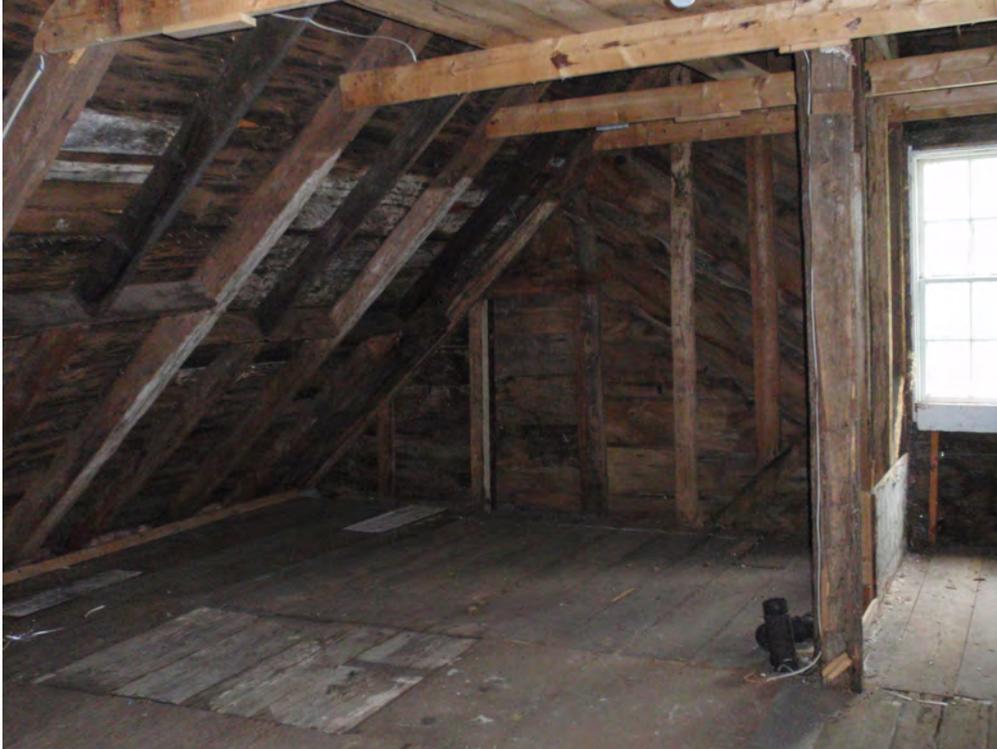
The framing of the Beverly jog is clearly visible in the attic (*fig. 10*). Two posts, one at the east gable end and another about nine feet west, placed over the beam visible in the east parlor downstairs, provide the major framing members. Mortises corresponding to the mortises visible in the east parlor are patched over in the attic, and would have held studs that were then

nailed into the front rafter (one is still there today). Three very tall studs run the height of the jog, from floor to ridgeline, between the two posts, creating the tall wall of the jog that faced south. These studs look to be in poor condition; however, given their height, the builder probably used whatever wood he could find that would be tall enough to fit the space.

Fig. 10 – Beverly jog framing on the right

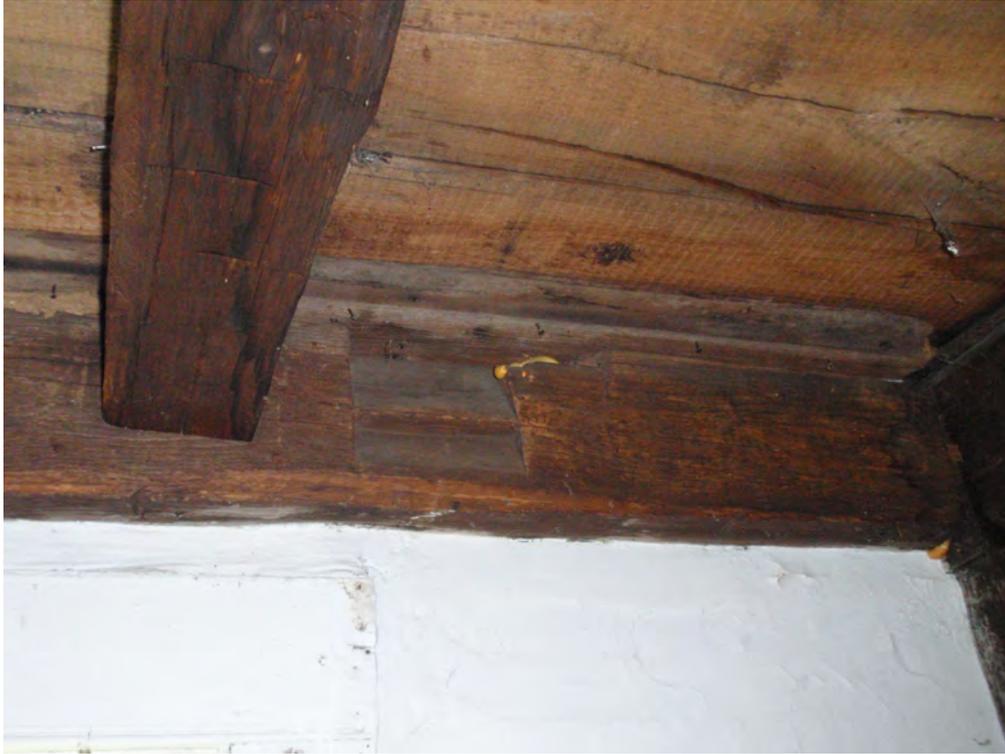
Fig. 11 – Reused plate, clapboard in east parlor

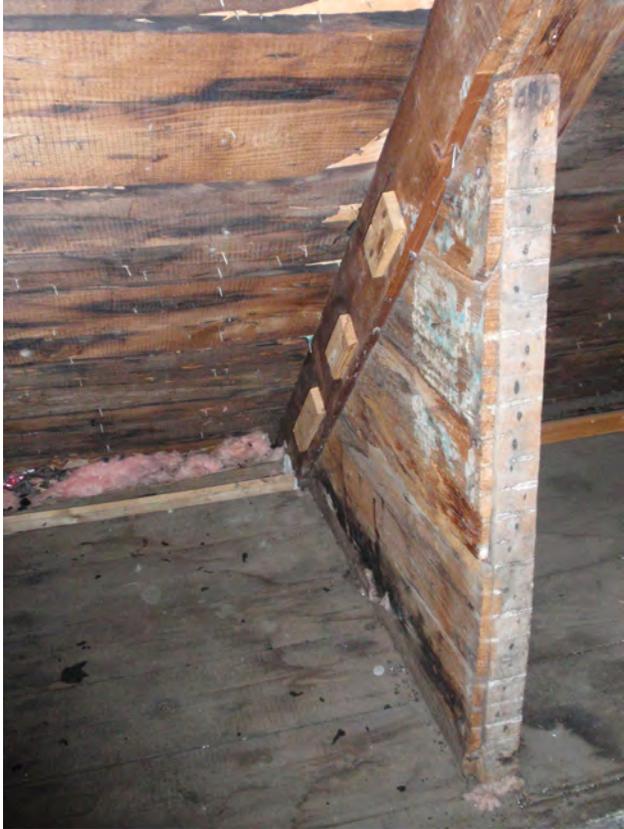
Fig. 12 – Possibly reused tapered sheathing

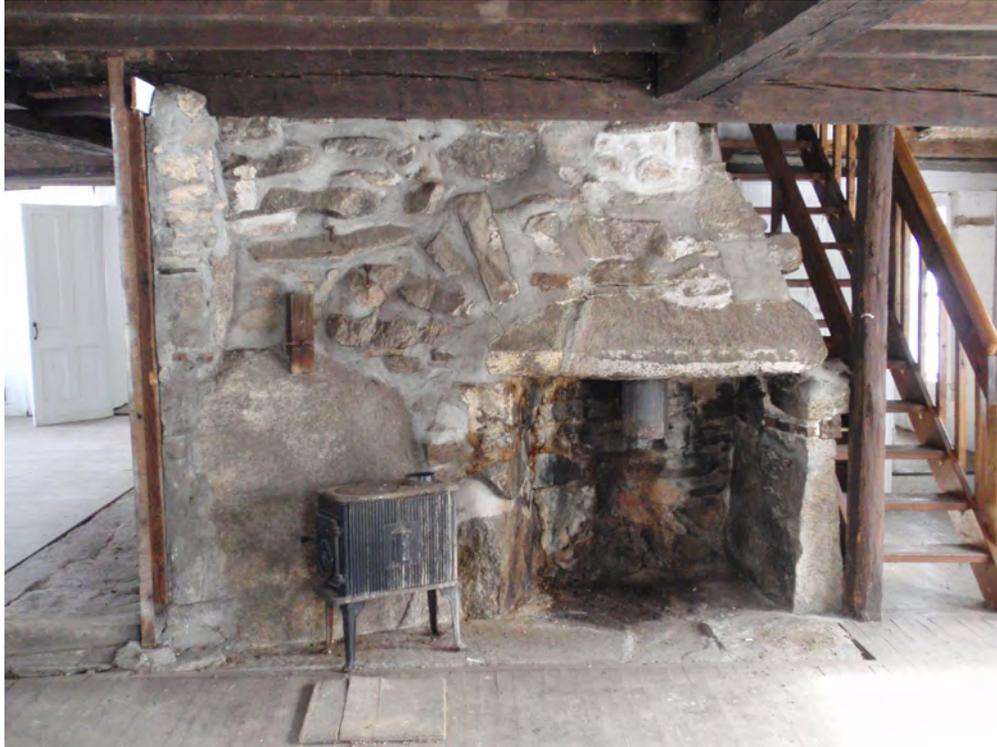
Fig. 13 – West hall fireplace

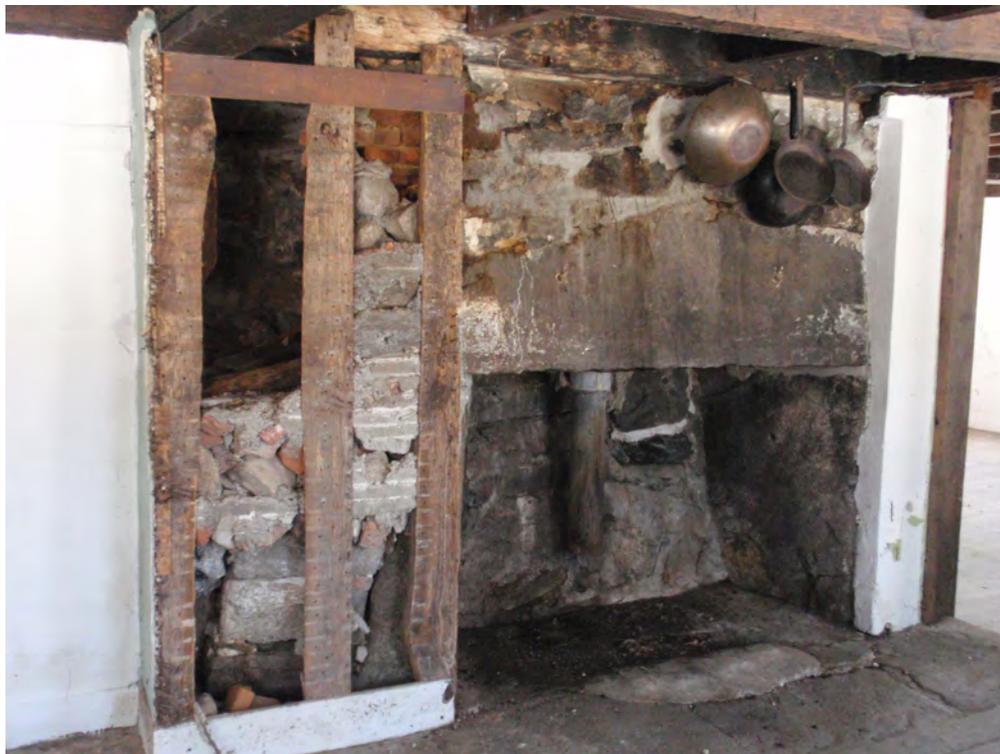
In the north room, there is evidence of an oven. To the left of the fireplace, a section that was walled over has been opened up to expose a number of crumbling bricks, creating an opening that passes through into the one in the east parlor (*fig. 14*). The studs used to cover this

section appear to be older, as they are split following the grain of the wood, and not like modern 2 x 4's. These studs have horizontal markings on them from a plaster and lath wall. As mentioned earlier, a gunstock post that is in this oven area has also been cut away, perhaps to fit some kind of cast iron oven. This may have been one of the original northeast corner posts from the west hall. Early bake ovens were placed in the back of fireplaces, to one side. But around the turn of the 19th century, external bake ovens were introduced, and so this oven's installation here may have coincided with the addition of the north and east rooms.

Fig. 14 – North room fireplace with oven on left

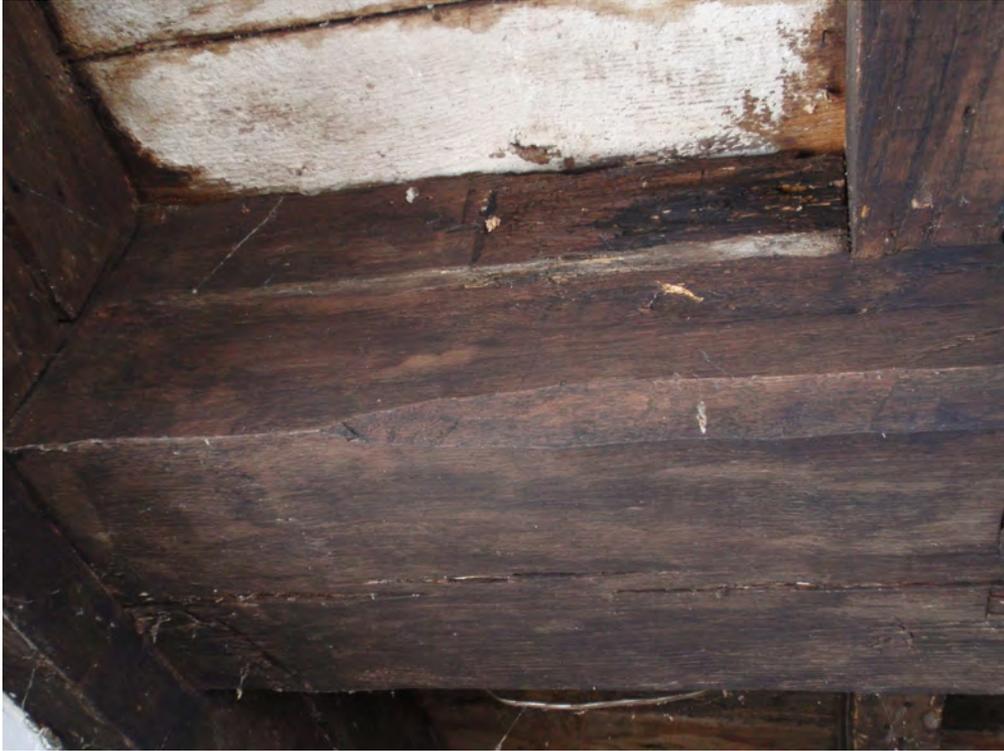
Fig. 15 – Chamfering on west hall summer beam

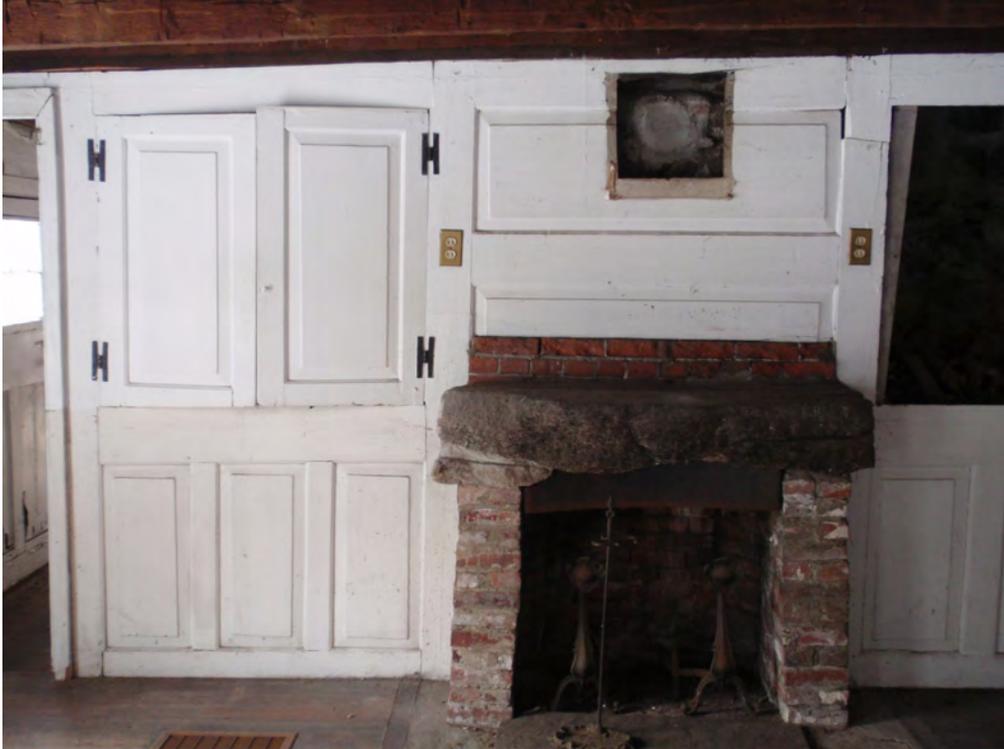
It seems likely that the paneling in the east parlor is original to the room's construction, as paneling was a common treatment in the late 1700s (*fig. 16*). However this paneling is a bit odd. Traditional Georgian paneling would have had the same number of panels on the top and bottom. Yet this paneling has three panels on the bottom but only two on top to the left of the fireplace; and on the right, two on the bottom and one on the top. The construction of the top right panel, now a door, is also a bit strange; the stiles of the door are quite wide, and do not seem to match the other panels on the wall. Preliminary paint analysis shows that the panels do have the same sequence of paint layers, so it may just be that the panels were constructed differently than what we have come to expect for the period. The single panel on the right that is now a door offers access to an odd hollowed-out space in the chimneystack. Originally this may have been some kind of side access to the oven in the north room. On the girt that runs through this little closet space, there is some sawn lath (*fig. 17*). It is held in place using transitional nails,

Fig. 16 – Paneling in the east parlor

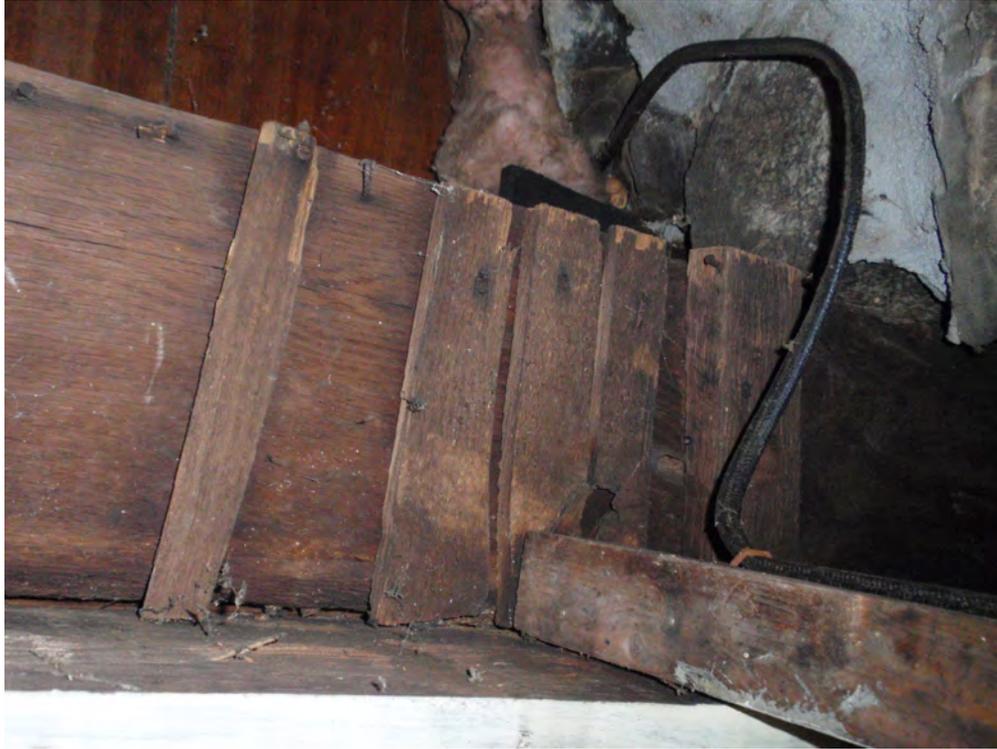
and is sawn, rather than the accordion lath found in the rest of the house. Perhaps when the oven was removed from the north room, this space was turned into a shallow closet or cabinet, and finished in plaster. The nails and type of lath give this space a date of 1820 to 1840, so perhaps it coincided with closing in the Beverly jog.

Fig. 17 – Lath in east parlor closet

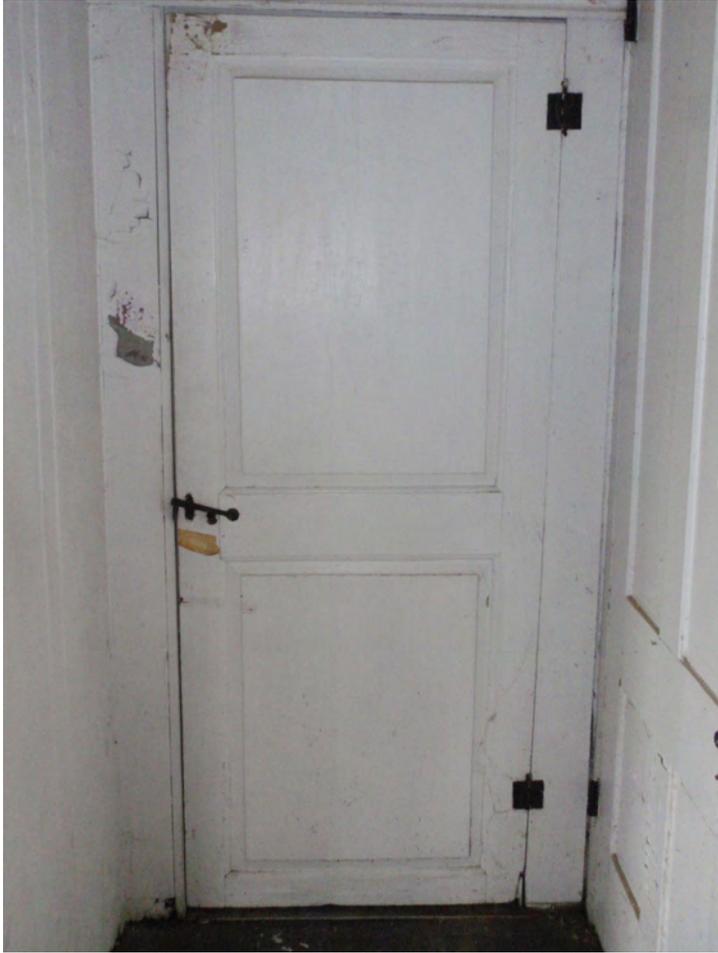
One of the more interesting doors in the house is the one on the smaller bathroom #1 (*fig. 19*). It appears to be a Georgian two-paneled door, with reproduction latch and slip-pin butt hinges. The door placement seems odd, as a paneled door such as this would usually not be used in a utilitarian space, such as a kitchen or bathroom. Preliminary paint analysis also shows a

different stratigraphy than that on nearby walls. This door has a red-brown ochre layer that does not seem to be present anywhere else in the house. This door may have been salvaged and reused from somewhere else, or just had an unusual paint color for the house.

Fig. 19 – Georgian door to bathroom
#1
